REQUEST FOR PROPOSAL TO PROVIDE PROFESSIONAL ENGINEERING SERVICES

Known Facts concerning the Panguitch Elementary Gymnasium:

Address: 100 S 165 W, Panguitch, Utah

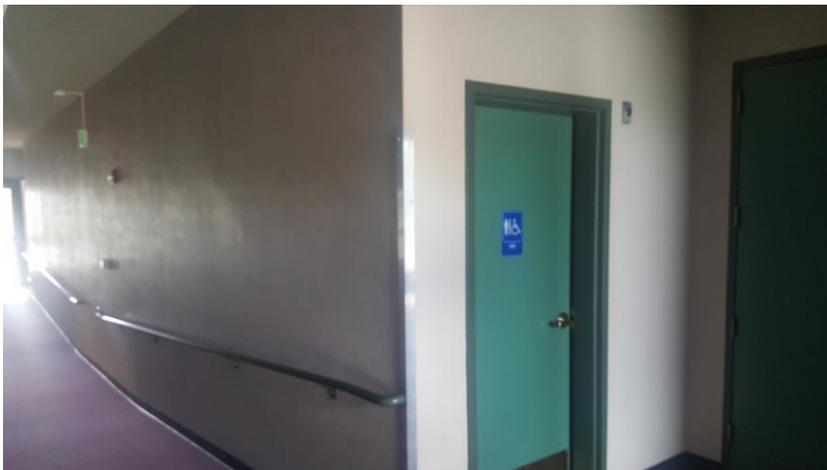
Entry hallway contains men and woman's bathrooms. The hallway sinks to the entry level of the existing school entry hallway. This floor could be leveled for aesthetics

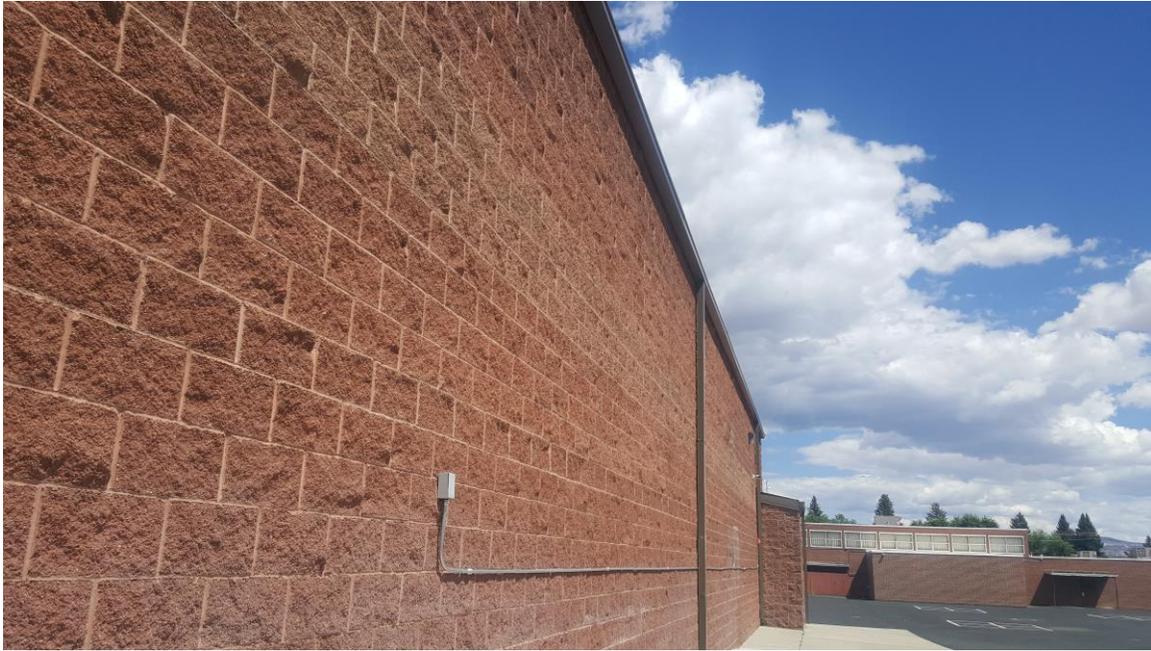
One of the main issues of the building is that the truss system ends on top of the walls and a poor collection system allows water to run down both sides of the wall; inside and out. This appears to have been happening since the gym was completed. The current gutter system comes straight down the wall and empties on the sidewalk and what water that makes it that far goes in the separation between the walls and the sidewalk.

1- Get the water away from the walls

4- New Rain Gutters and water collection system piped to French drains away from building foundation

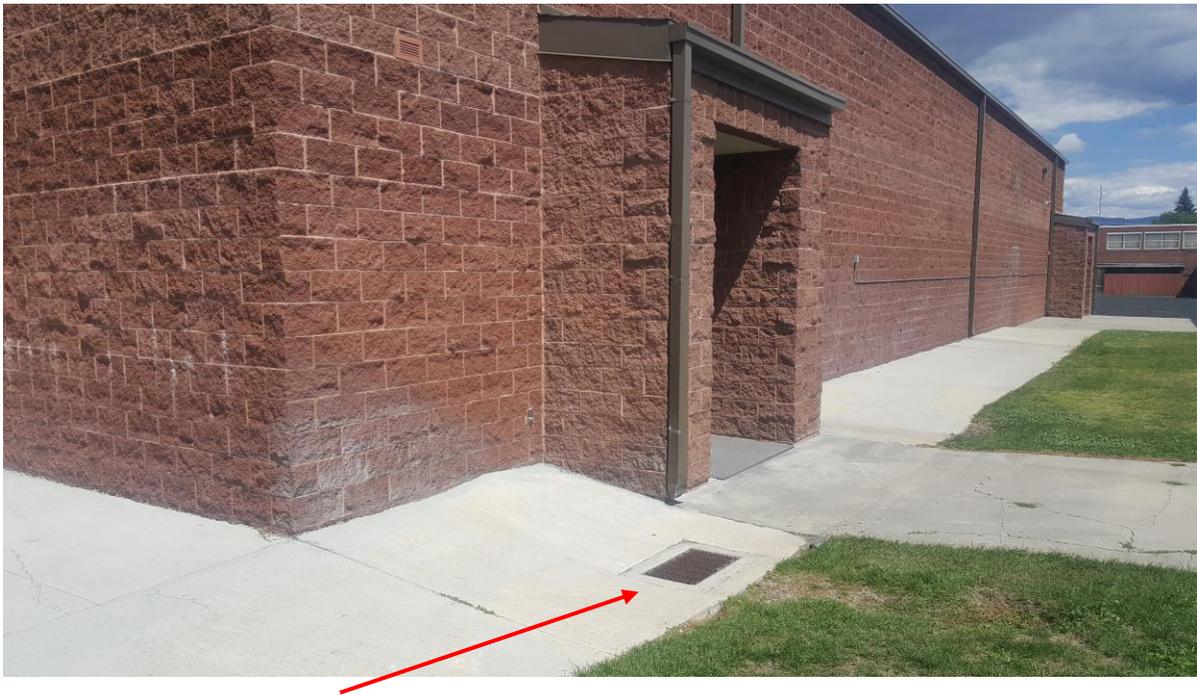
The water that makes it to the ground is channeled to a French drain within 5 feet of the building which is thought to have caused a sinking condition for the SW corner of the building.

3- New French drains away from the building foundation that tie to the rain collection system

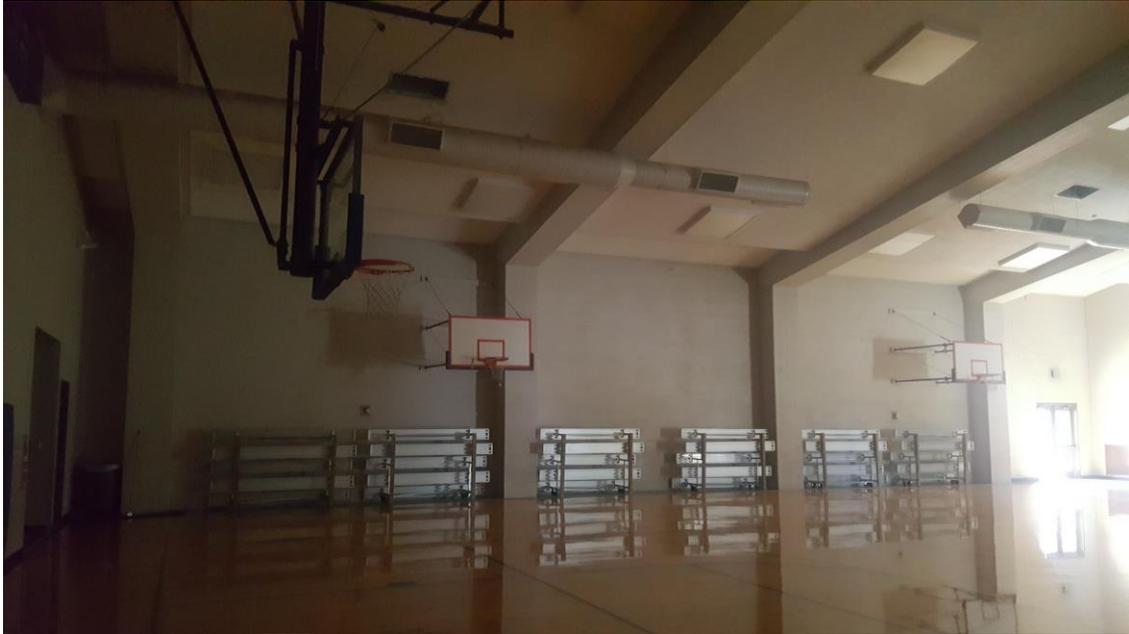
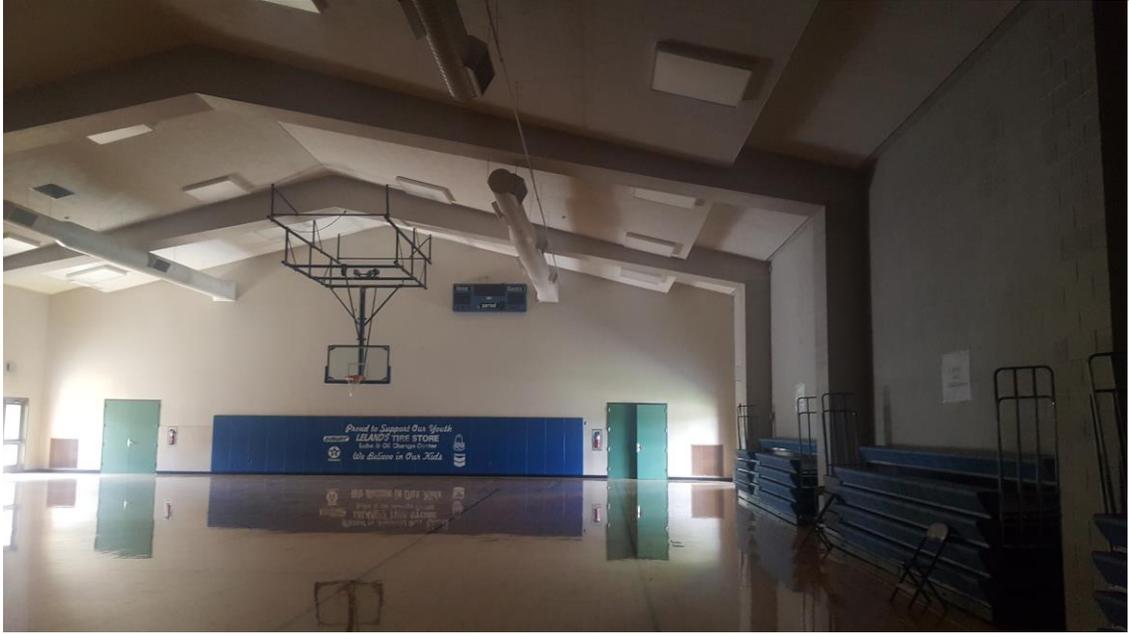
Interior of the gymnasium is in great shape but the building has stains from water coming down the inside walls as well as the exterior walls. Stress cracking is visible on most wall faces.

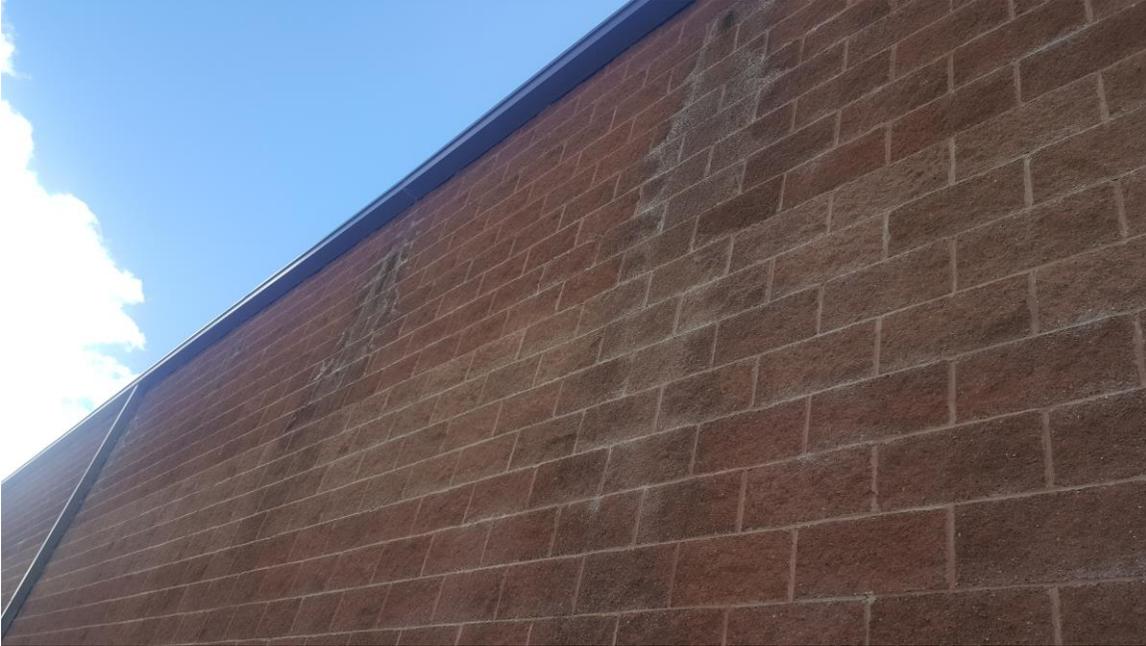
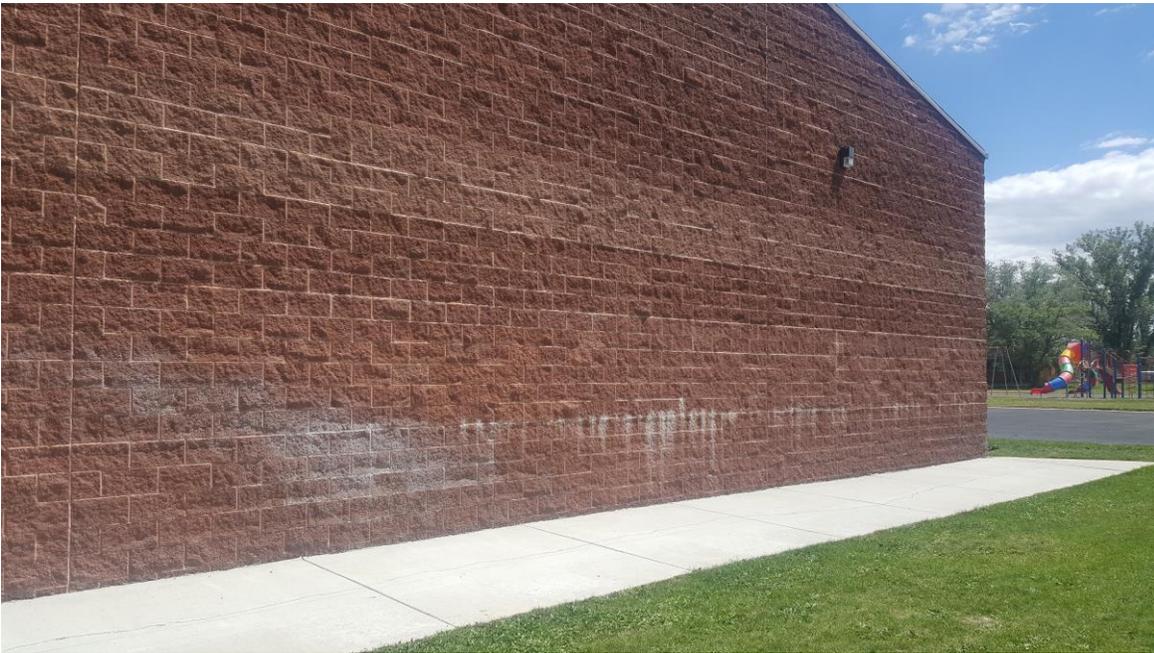
Staining on the exterior walls show leaching and hard water paths
